## KARSTIC GEOLOGY INVESTIGATION REPORT

Clinton Moebus 34, LLC  
65 ½ Center Street  
Block 14 Lot 32  
Town of Clinton,  
Hunterdon County,  
New Jersey

Prepared For:  
AMBE Holdings at Clinton, LLC  
3 Meha Court  
Manalapan, NJ 07726

March 5, 2020

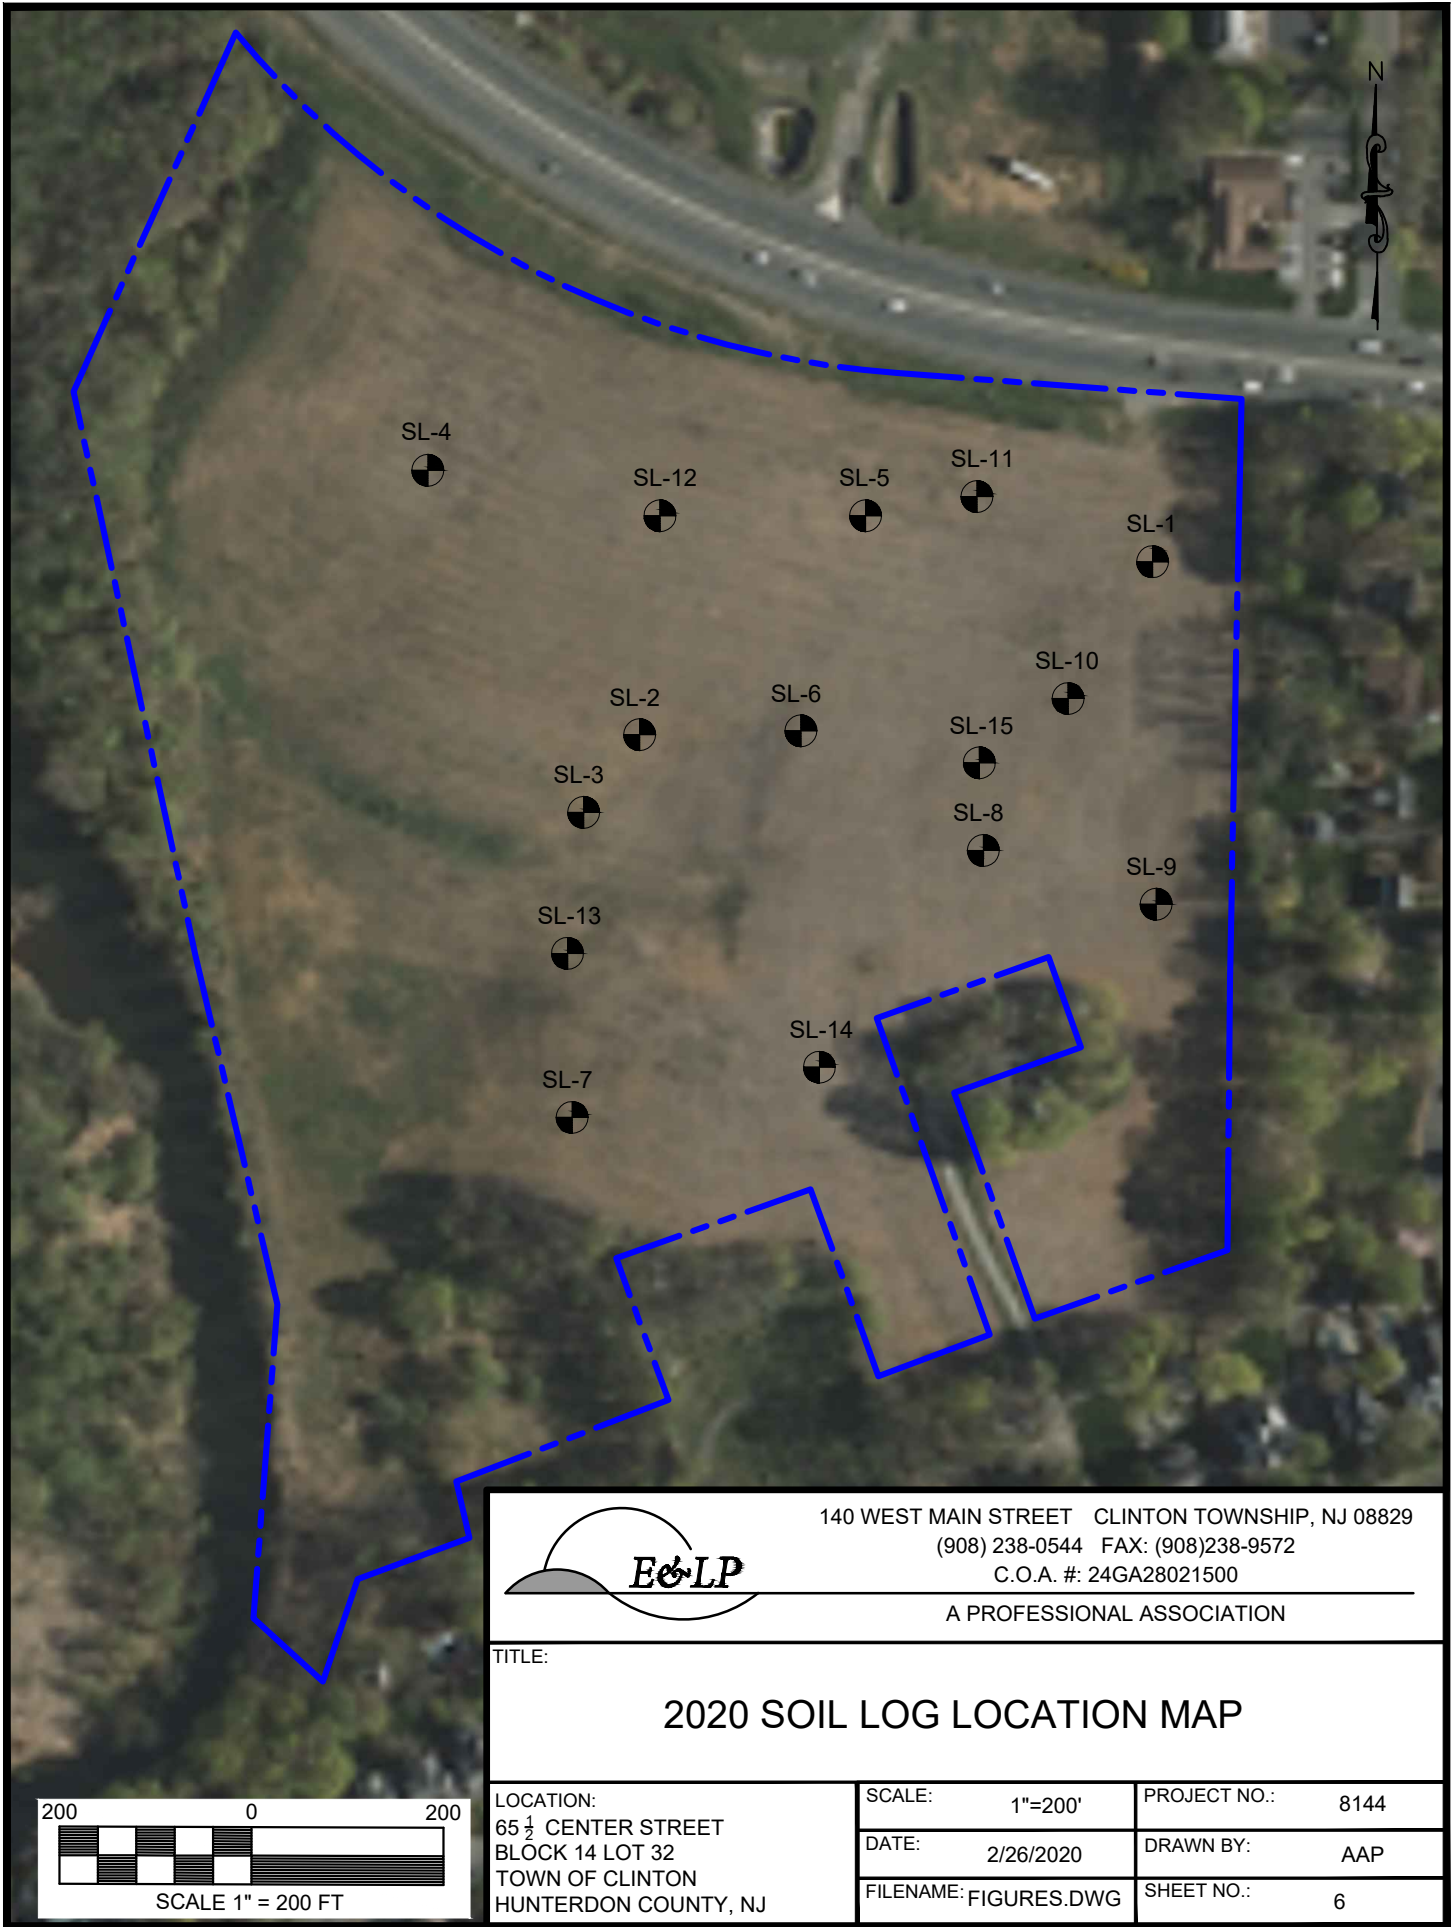
## 2020 SOIL LOG LOCATION MAP

On April 17, 2020 Engineering & Land Planning Associates, Inc. conducted fifteen test pits to confirm the findings of the 2009 soil sampling. Bedrock was encountered in all of the test pits, excluding SL-2 and SL-3, shown on Figure 6. Neither groundwater nor soil mottling was encountered in the test pits, excluding SL-2, SL-3, and SL-6. SL-2 contained many signs of mottling at a depth of 95". SL-3 contained no mottling but evidenced seepage at a depth of 123". SL-6 contained common signs of mottling and evidence of seepage at a depth of 96".

Other than the fill soils evidenced on the northern portion of the site which were gravelly, the majority of the native site soils consisted of clays which are of very low permeability and likely not suitable for infiltration. As seen in the most recent soil logs (Appendix B), it is recommended that stormwater management systems be located in the vicinity of SL-2 and SL-3.

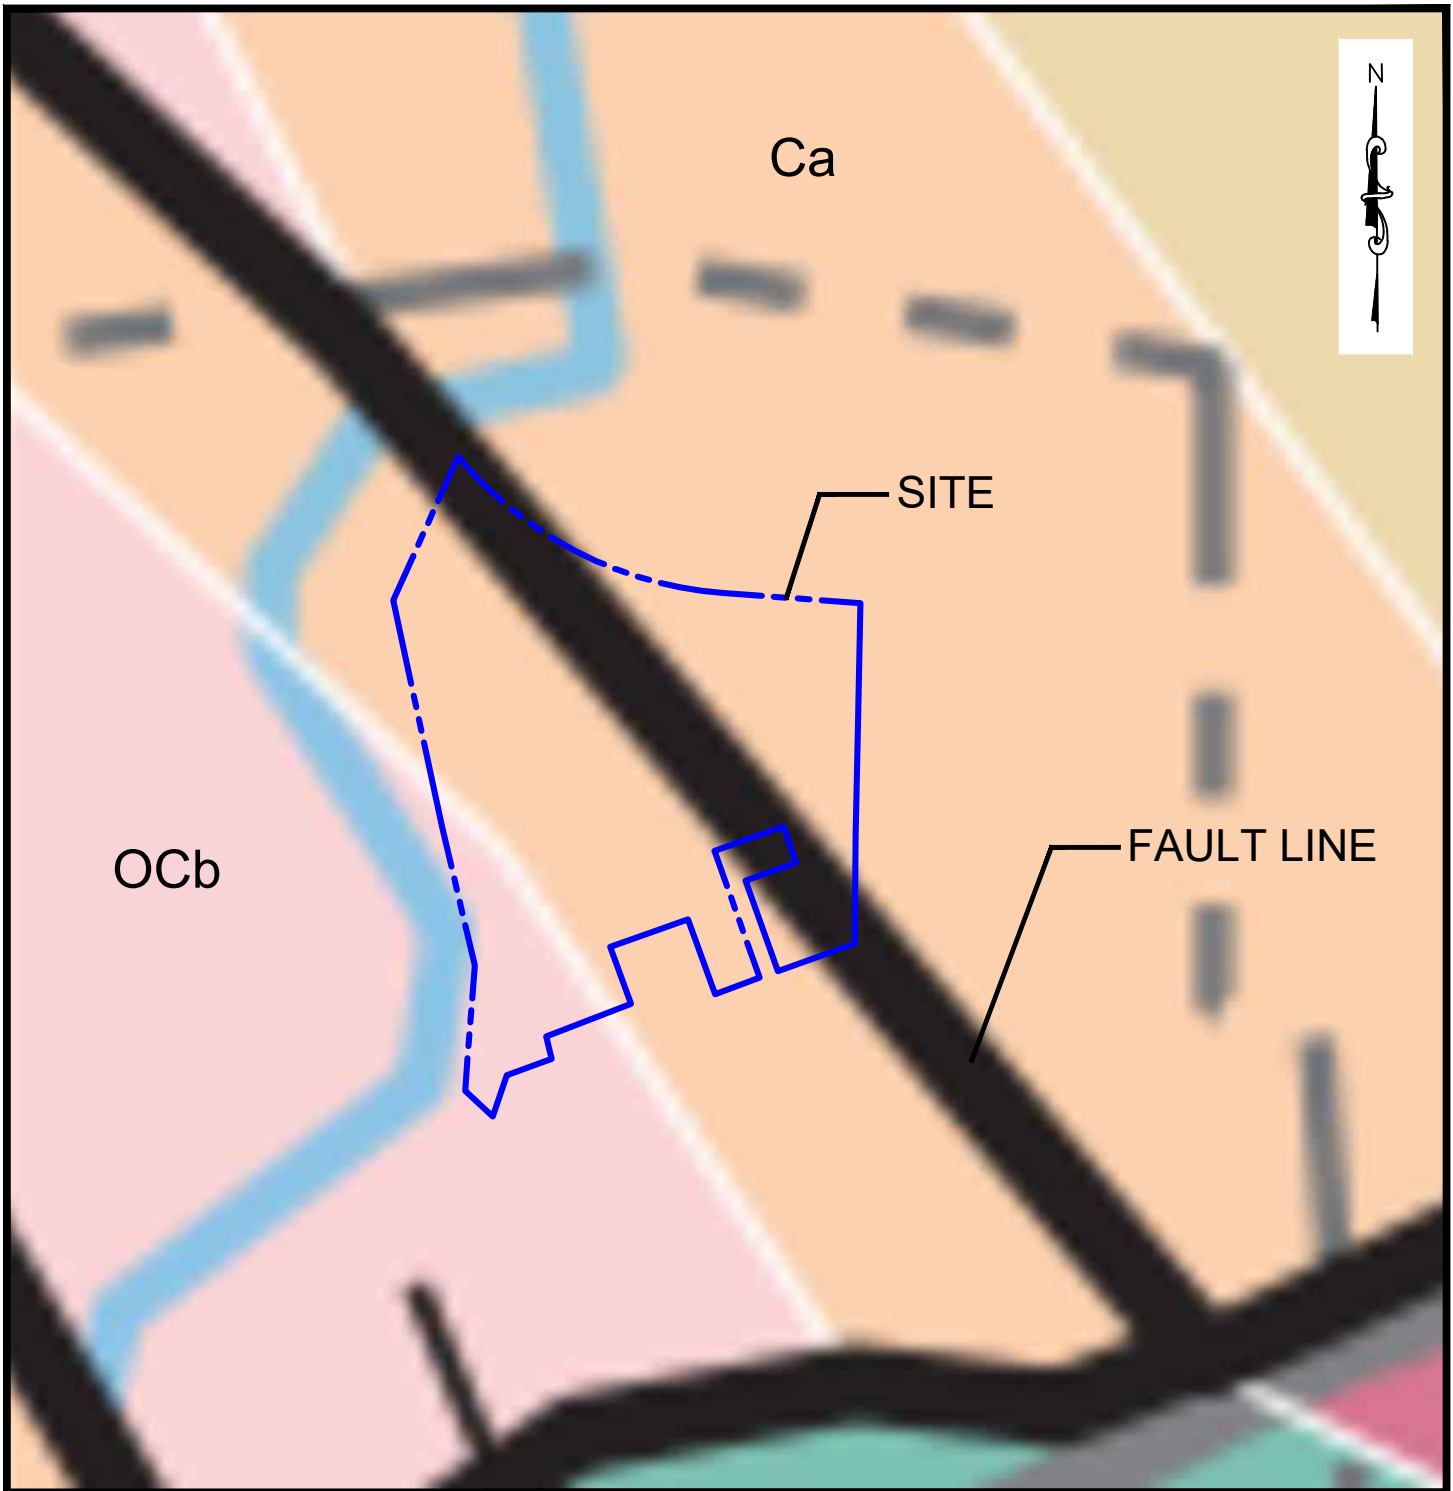
TITLE:  
**BEDROCK GEOLOGY MAP**

The bedrock geology beneath the site is known as Allentown Dolomite and Lower Beekmantown Group, which are both part of the Kittatinny Supergroup, aging to the Lower Ordovician and Upper Cambrian. The Allentown Dolomite bedrock beneath the Site has been folded, refolded, and thrust faulted. These deformation systems have resulted in an apparent regional bedding dip of about 70 degrees to 80 degrees to the west-northwest with a bedding strike of approximately north south to north-northeast, see Appendix A. There is a single thrust fault plane bisect to the property, see Figure 7. However, it appears to be refolded and therefore should not create any unusual geotechnical conditions. There are no observed rock outcrops naturally existing on the property.

In this part of New Jersey, this formation (Allentown Dolomite) is medium to light gray very thin to thick bedded dolomite with minor orthoquartzite and shale beds (Drake et.al., 1996). Bedding surfaces and some fractures display dissolution surfaces but the degree and extent do not appear wide spread. Karstic terrane characteristics are commonly pinnacled and troughed because of the variable lithologies and weathering variability. However, the orthoquartzite and shale beds do reduce the scale and extend of the potential karstic cavities.

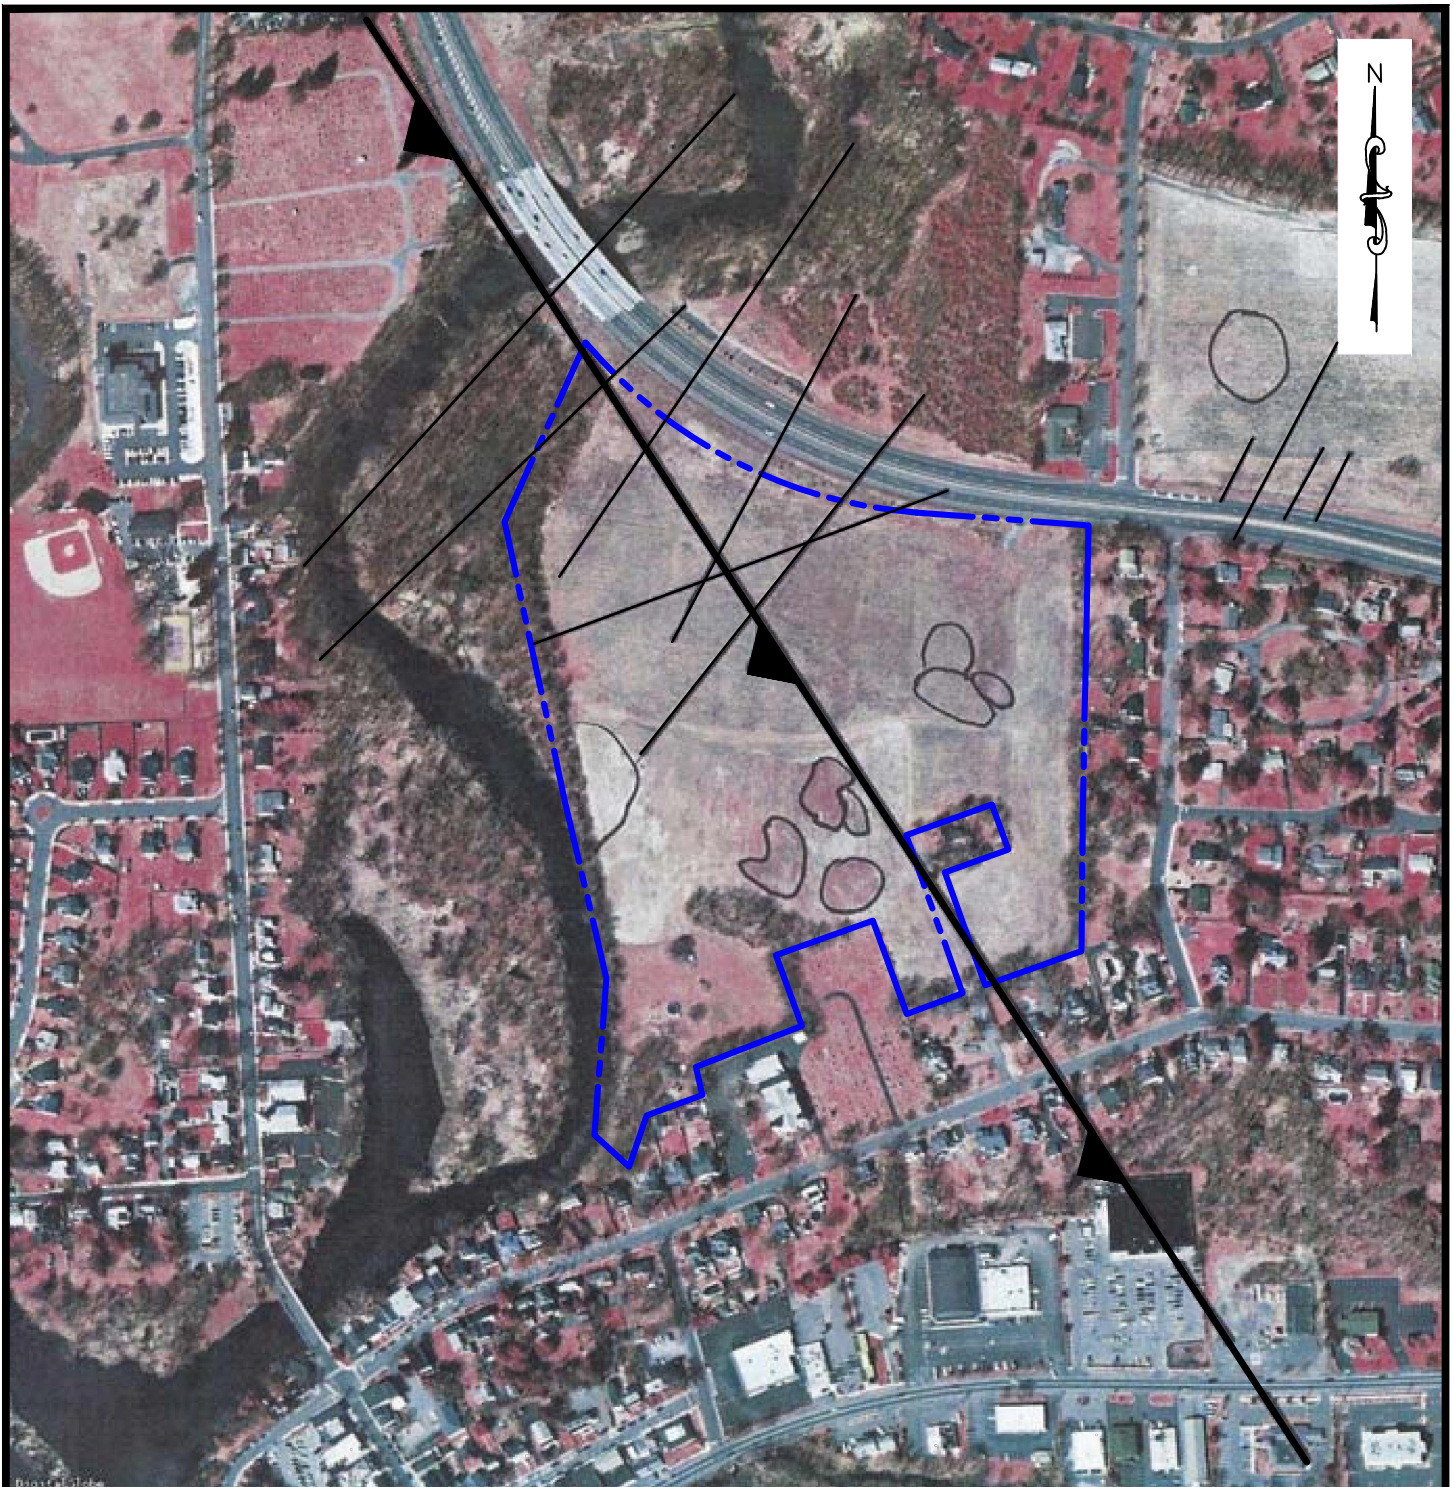
**KARSTIC FEATURE MAP**

Numerous stereo pairs from the USGS & USDA photo archive in the Library were studied for historical karst terrain features. Limited Karst activity can be observed from aerial photography in the surrounding properties. The base photo for Figure 8 is a 2002 USGS NAPP color infra-red (CIR). EpiKarst features are very distinct on CIR, due to the surface to subsurface temperature differentials. The actual subject property has very few epikarst features (closed depressions) and most of those are phantom features manifested on the surface through the fill.

As mentioned above, the epikarst depressions (sinks or dolines) from the photography were not field observed are not considered severe. The foundation investigation's placement of boring can aid in confirming there are no unforeseen subsurface conditions. These may be easily remedied with construction proofing protocols. This is always prudent and is considered standard practice within the region (Sowers, 1996). The boring plan may be modified as mentioned above. If significant subsurface voids are found, a geophysical investigation or additional borings may be warranted.
